FIXING A DIAMOND X-500 2/70 ANTENNA

JANUARY 8, 2018 BY ADAM

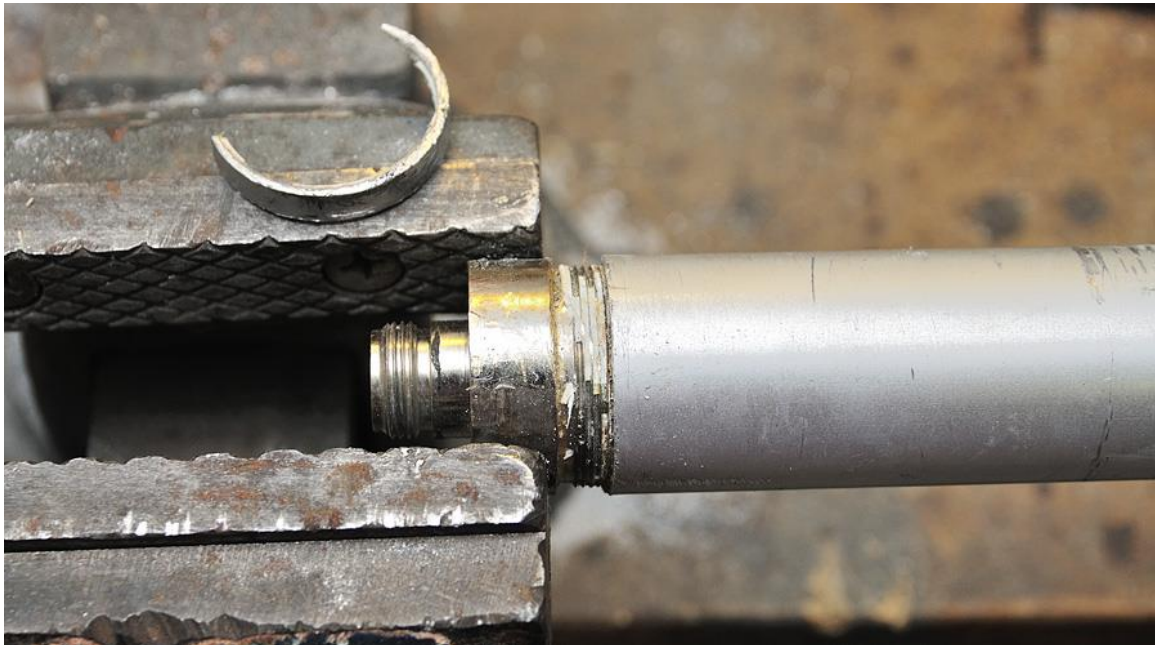
Above: The brass end with the N connector screws into the aluminum base tube section.

Even clamping this in a vice, and attempting to turn the aluminum tube section failed. The brass end screws into the tube, but is held with adhesive as well.

I found that by carefully hacksawing 3-4mm off the end of the tube made it much easier to unscrew and separate the two.

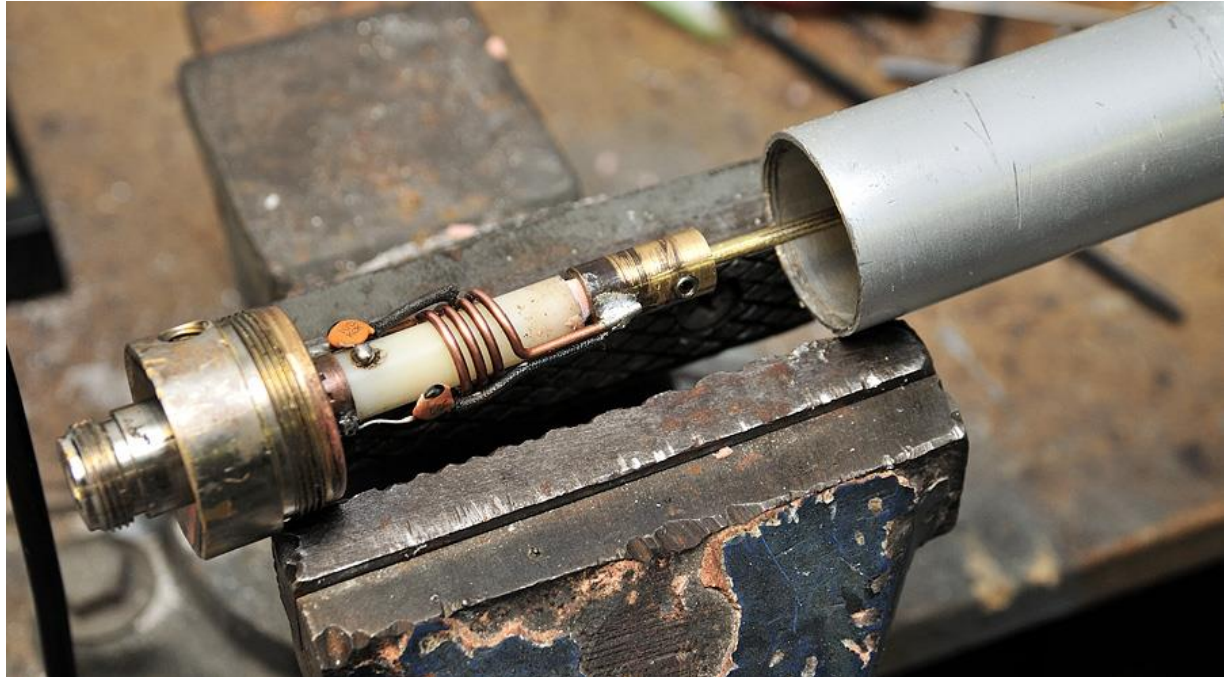
Above: This is what's inside! A tapped coil, a 10pF ceramic in series with coax inner, and a 1.5pF shunt.

With these standard ceramic caps, you can understand why these antennas only have a 200W PEP rating.

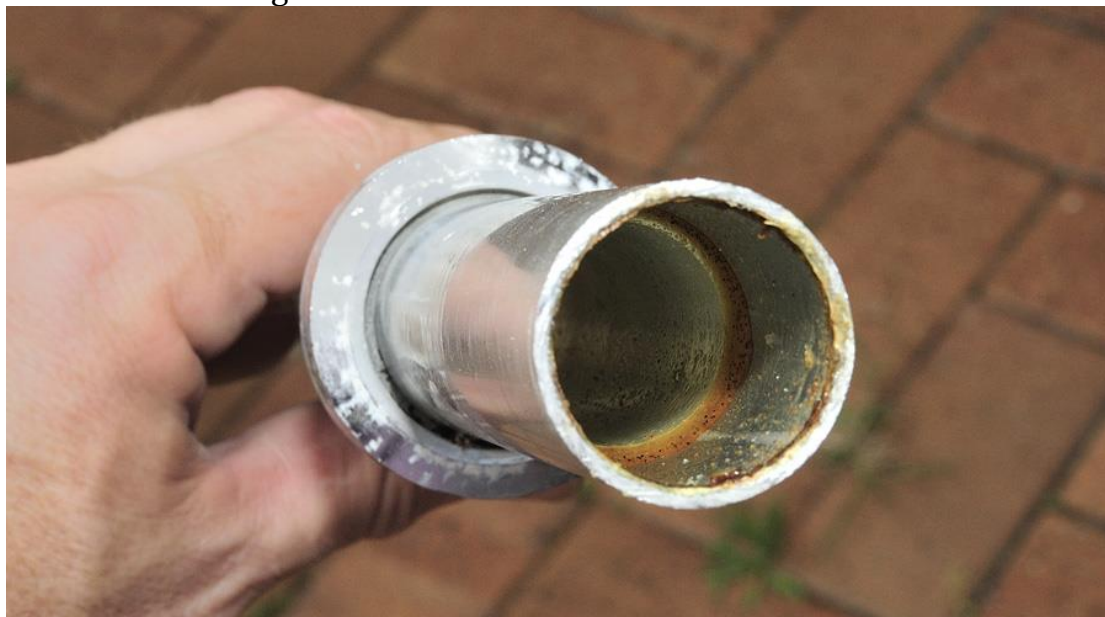
Above: The fibreglass radome section is glued into the base aluminum tube.

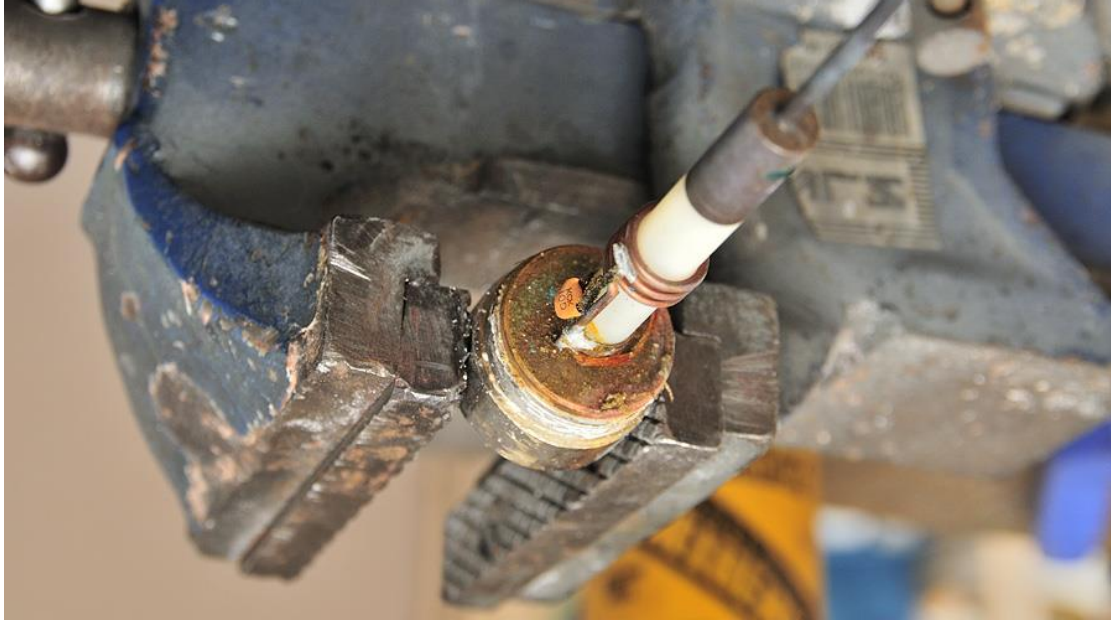
Above: 20 years of moisture and gunk build up inside these things.

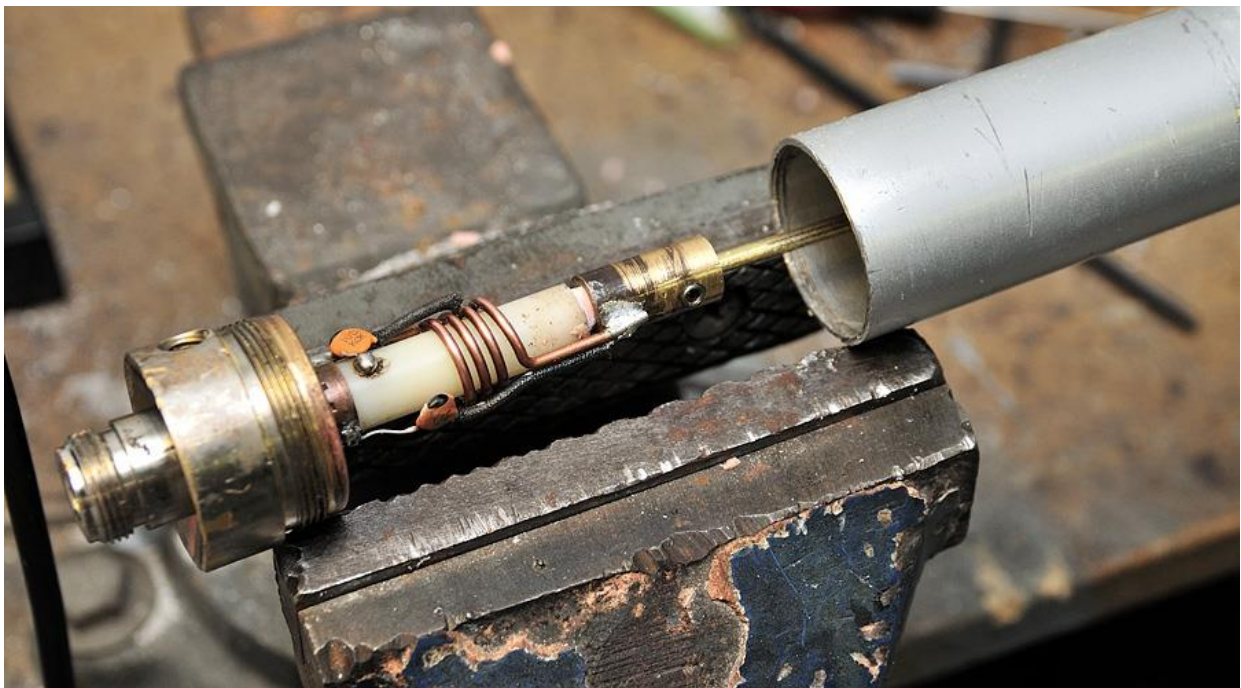
Unfortunately I applied too much heat (using a large Weller 700F tip), and the end of the nylon former (on which the brass end/joiner screwed on to) became soft and melted out of shape.

Anyway, to cut a long story short, I had to reform the end of this nylon former so the copper end could be screwed back on, keeping the dimensions the same.

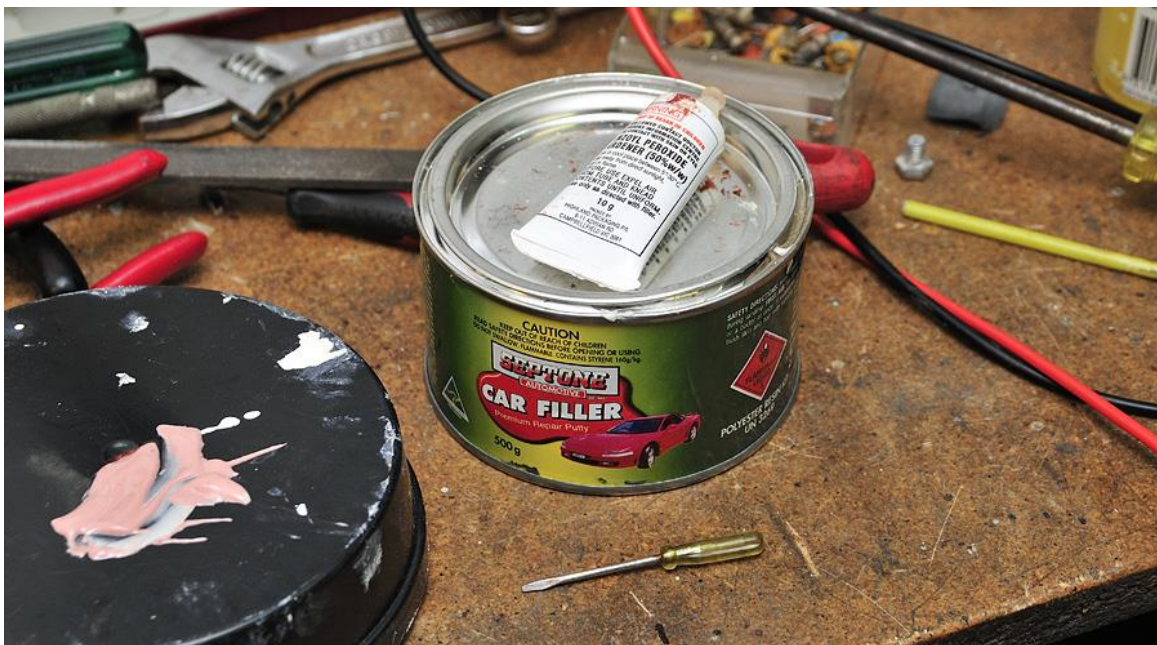
Above: Using electrical tape to form the sides, a small amount of 2-part automotive bog was used to fill in the bit that melted off!
Under this, for strength, I drilled a hole into the nylon and then banged in a small fibreglass plug (an inch or so off an old helical whip).
Around this, I added the bog.

All of this could have been avoided if I was a bit more careful in the beginning! 😞

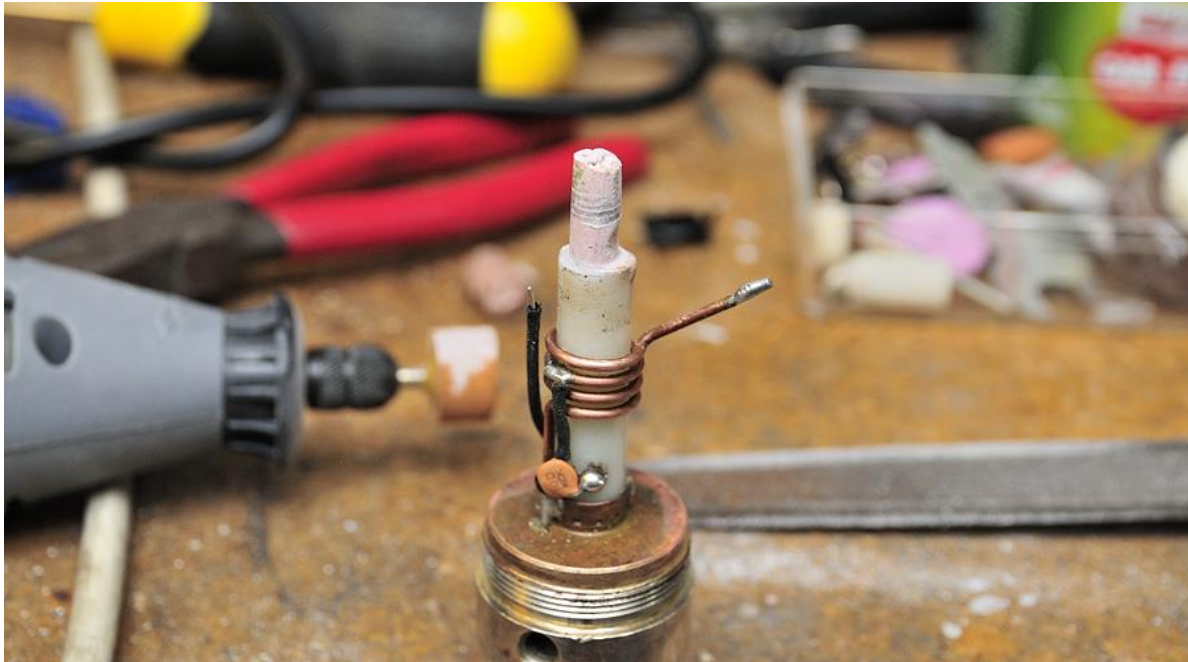
Above: the reformed end.

The new end was rounded down to size using an Ozito grinding tool, and a flat file. The brass end was tightly fitted on with a bang of a hammer!
